Libby Asbestos Superfund Site
The Former Screening Plant and Surrounding Properties,
Operable Unit 2
Lincoln County, Montana

Final Remedial Action Report

USACE Contract No. W9128F-11-D-0023

April 20, 2012

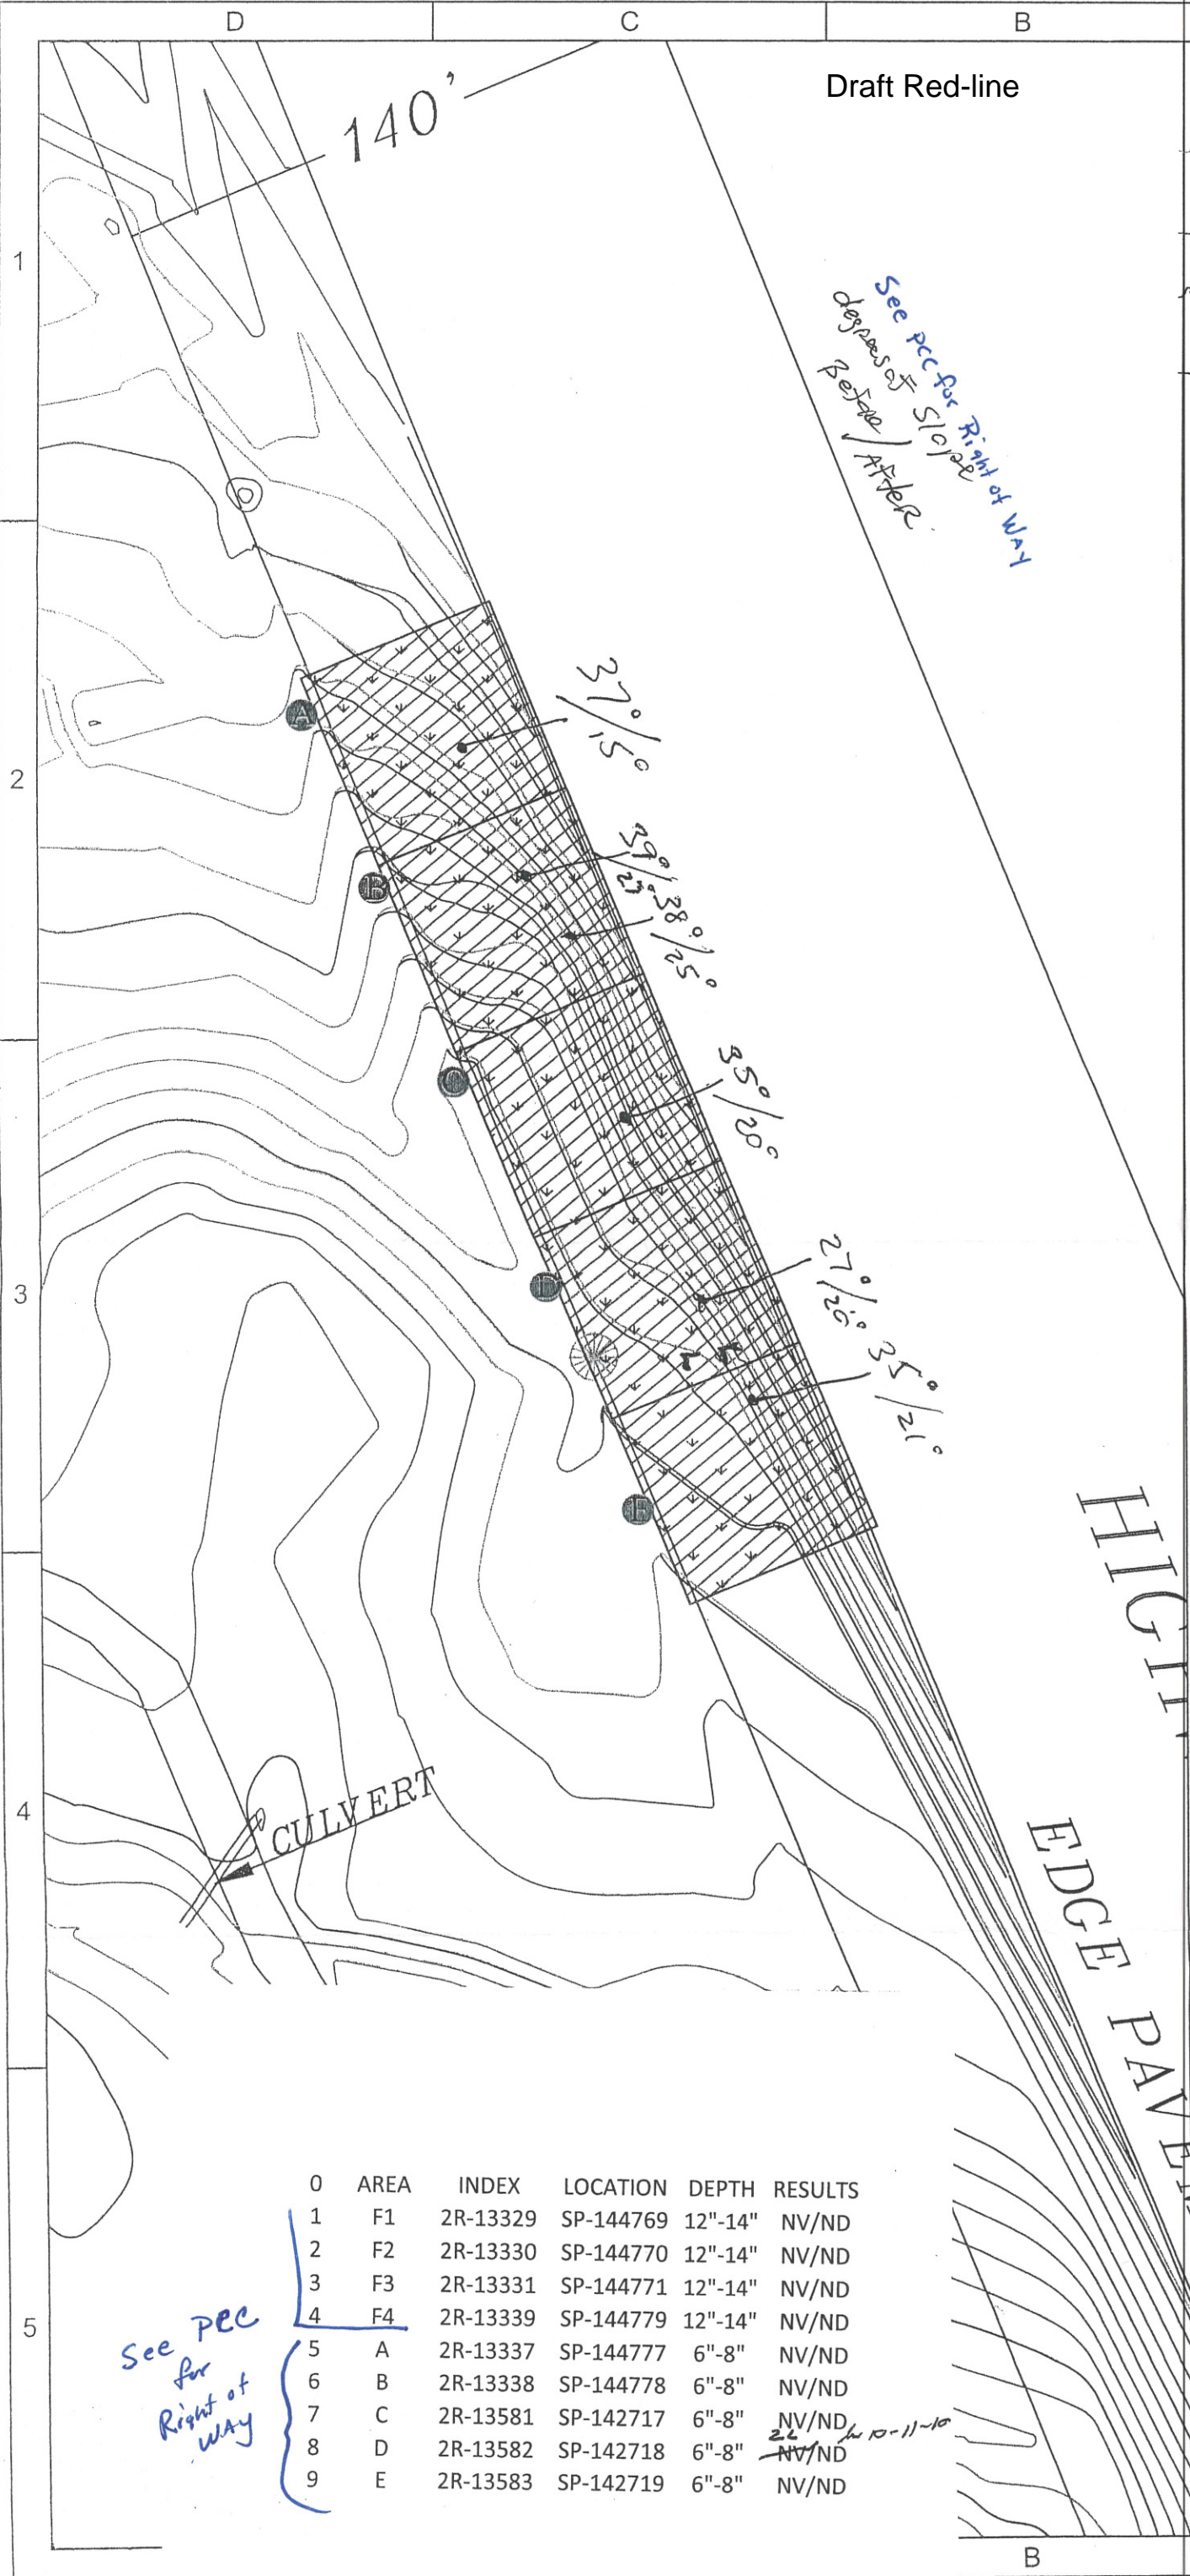
TOTAL FILL VOLUME:
863 CU. YDS.

0	AREA	INDEX	LOCATION	DEPTH	RESULTS
1	F1	2R-13329	SP-144769	12"-14"	NV/ND
2	F2	2R-13330	SP-144770	12"-14"	NV/ND
3	F3	2R-13331	SP-144771	12"-14"	NV/ND
4	F4	2R-13339	SP-144779	12"-14"	NV/ND
5	A	2R-13337	SP-144777	6"-8"	NV/ND
6	B	2R-13338	SP-144778	6"-8"	NV/ND
7	C	2R-13581	SP-142717	6"-8"	NV/ND
8	D	2R-13582	SP-142718	6"-8"	NV/ND
9	E	2R-13583	SP-142719	6"-8"	NV/ND

6. RESTORATION CONTRACTOR IS TO REPLACE AREAS A, B, C, D, E, AND F WITH HYDRO-SEED.

- 3" SCRAPE BELOW EXISTING GRADE
- 9" OF COMMON FILL MATERIAL
3" OF TOPSOIL AND HYDROSEED PLACEMENT

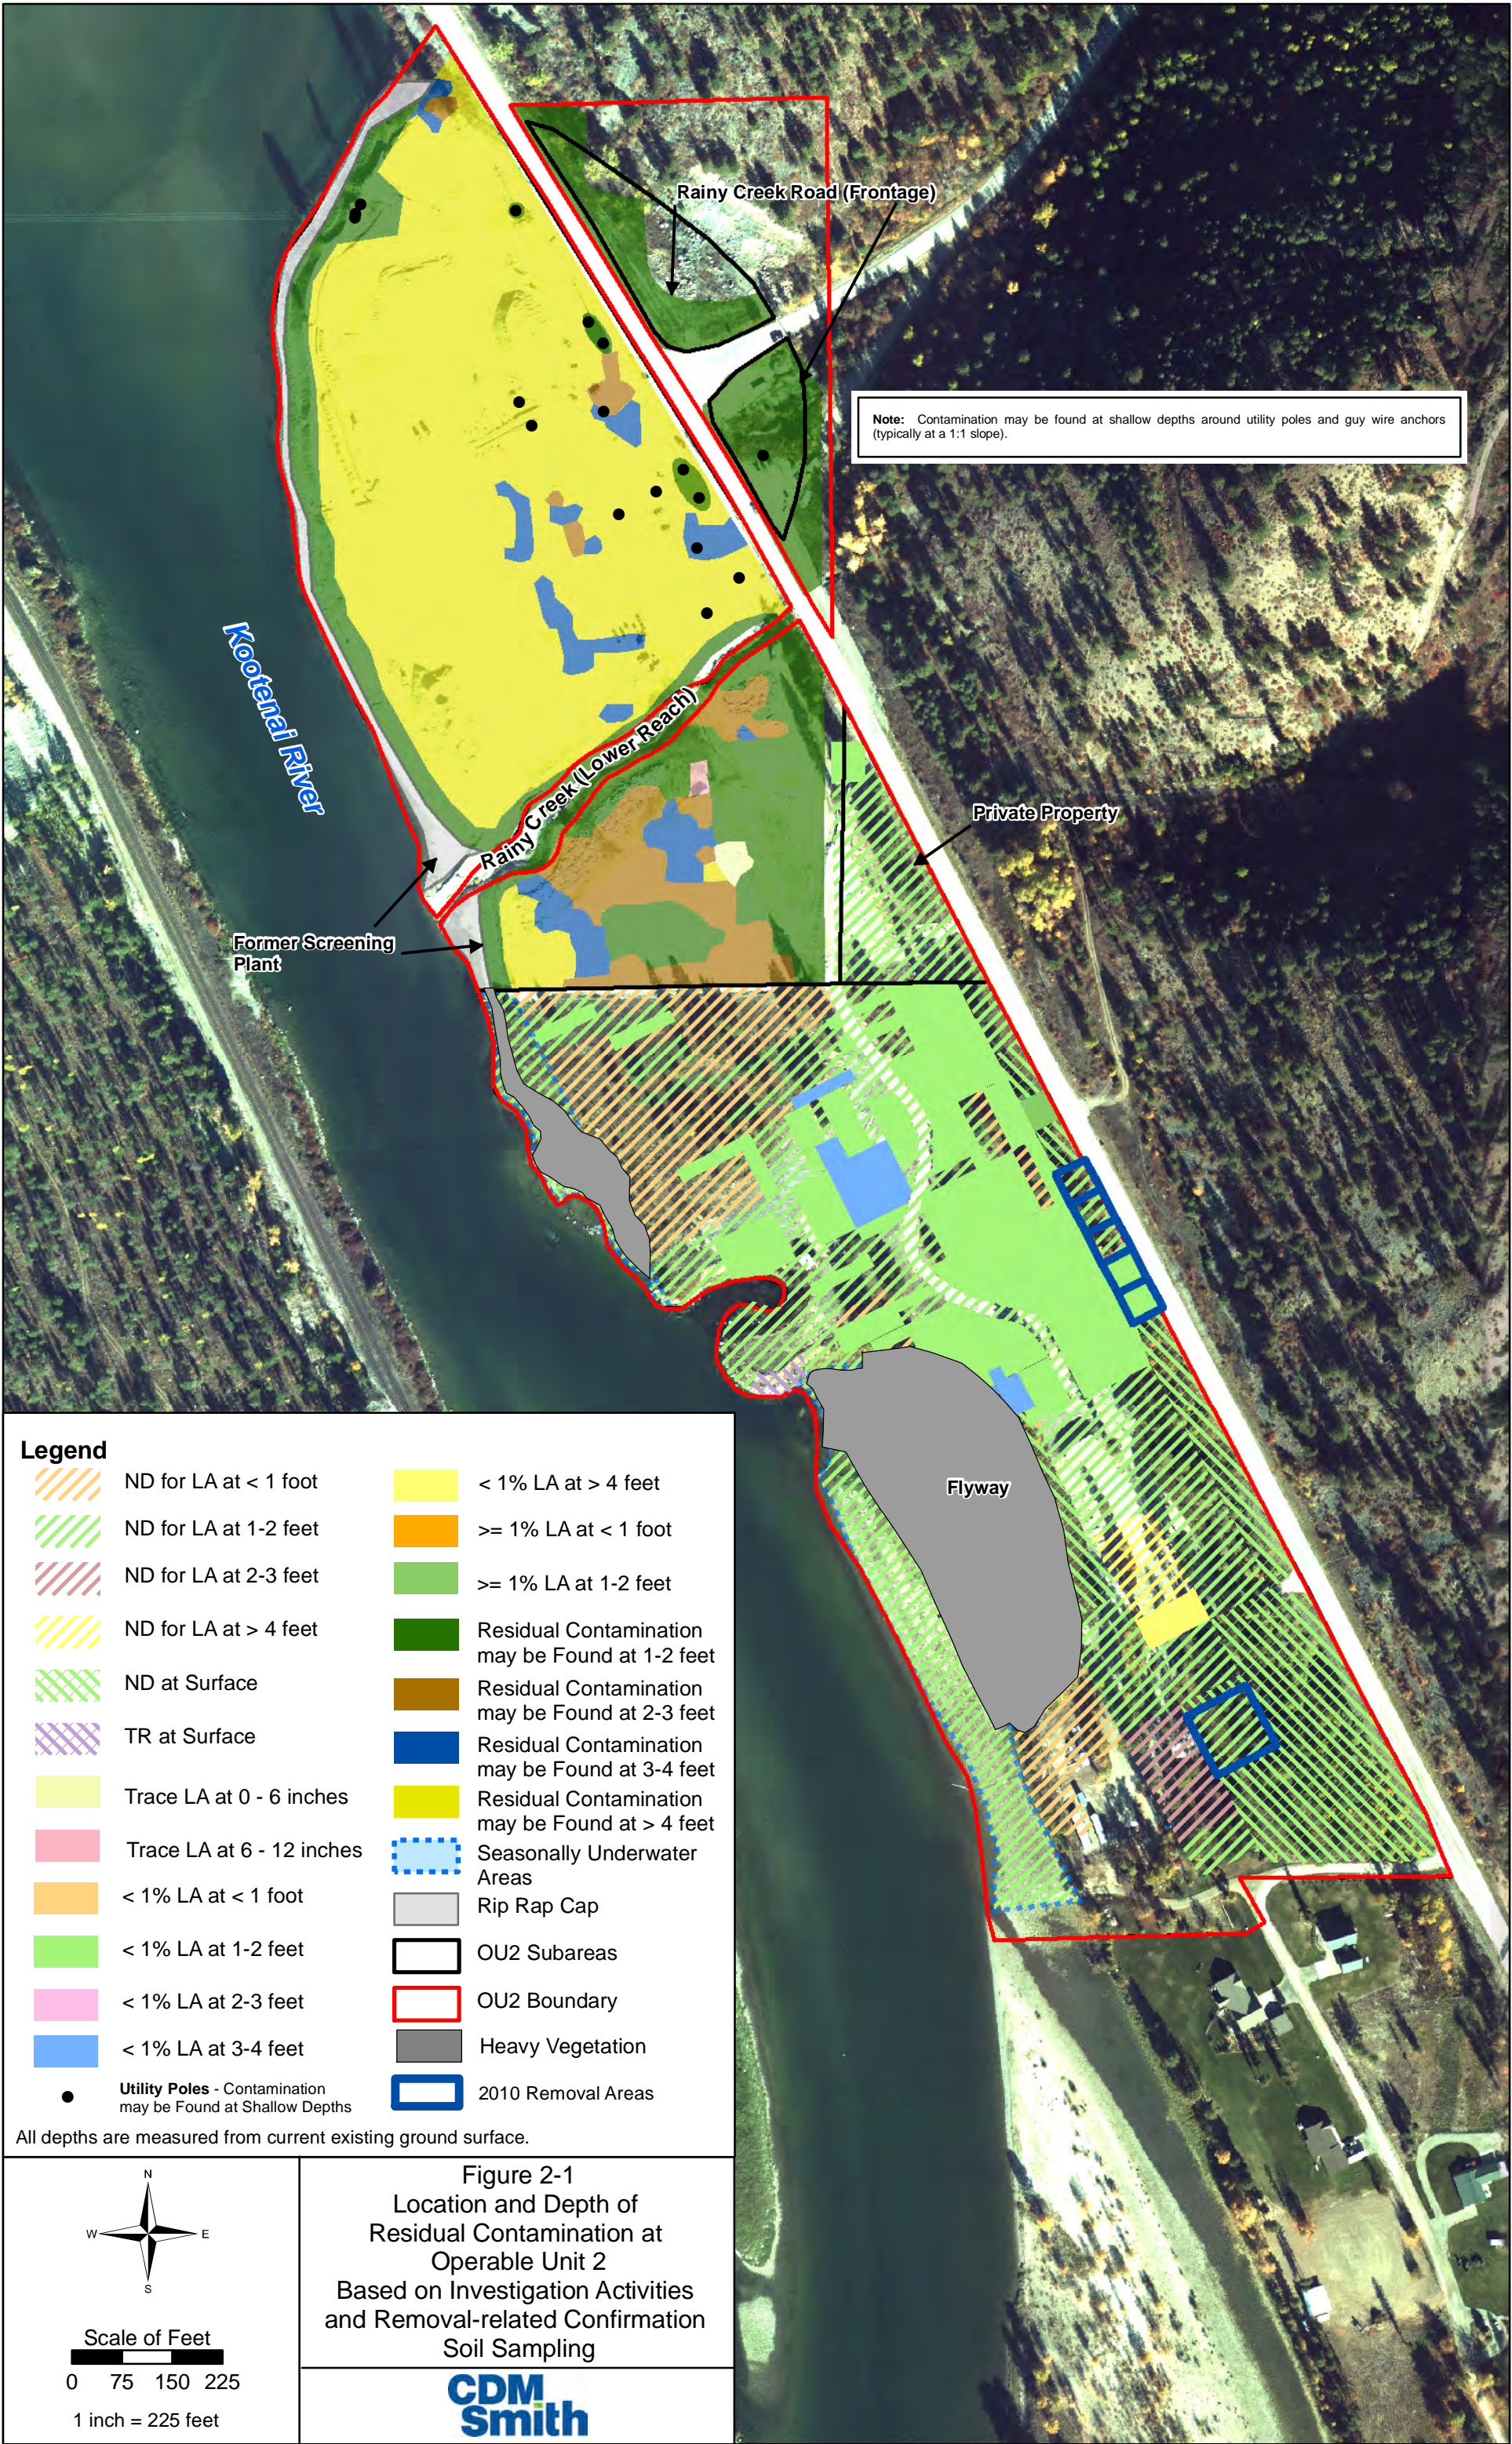
Figure 2-2
Location and Depth of Residual Contamination
at OU2 - Parker Property Based on
Investigation Activities and Removal-related
Confirmation Soil Sampling
Libby Asbestos Superfund Site
Lincoln County, Montana

| Residual Contamination may be Found at 1-2 feet | Utility Pole |
